WELLS G AND H
ADMINISTRATIVE RECORD

SITE INSPECTION REPORT
of
JOHN J. RILEY COMPANY
(A Division of Beatrice Foods)
228 Salem Street
Woburn, Massachusetts

SITE INSPECTION REPORT

JOHN J. RILEY COMPANY
(a Division of Beatrice Foods)

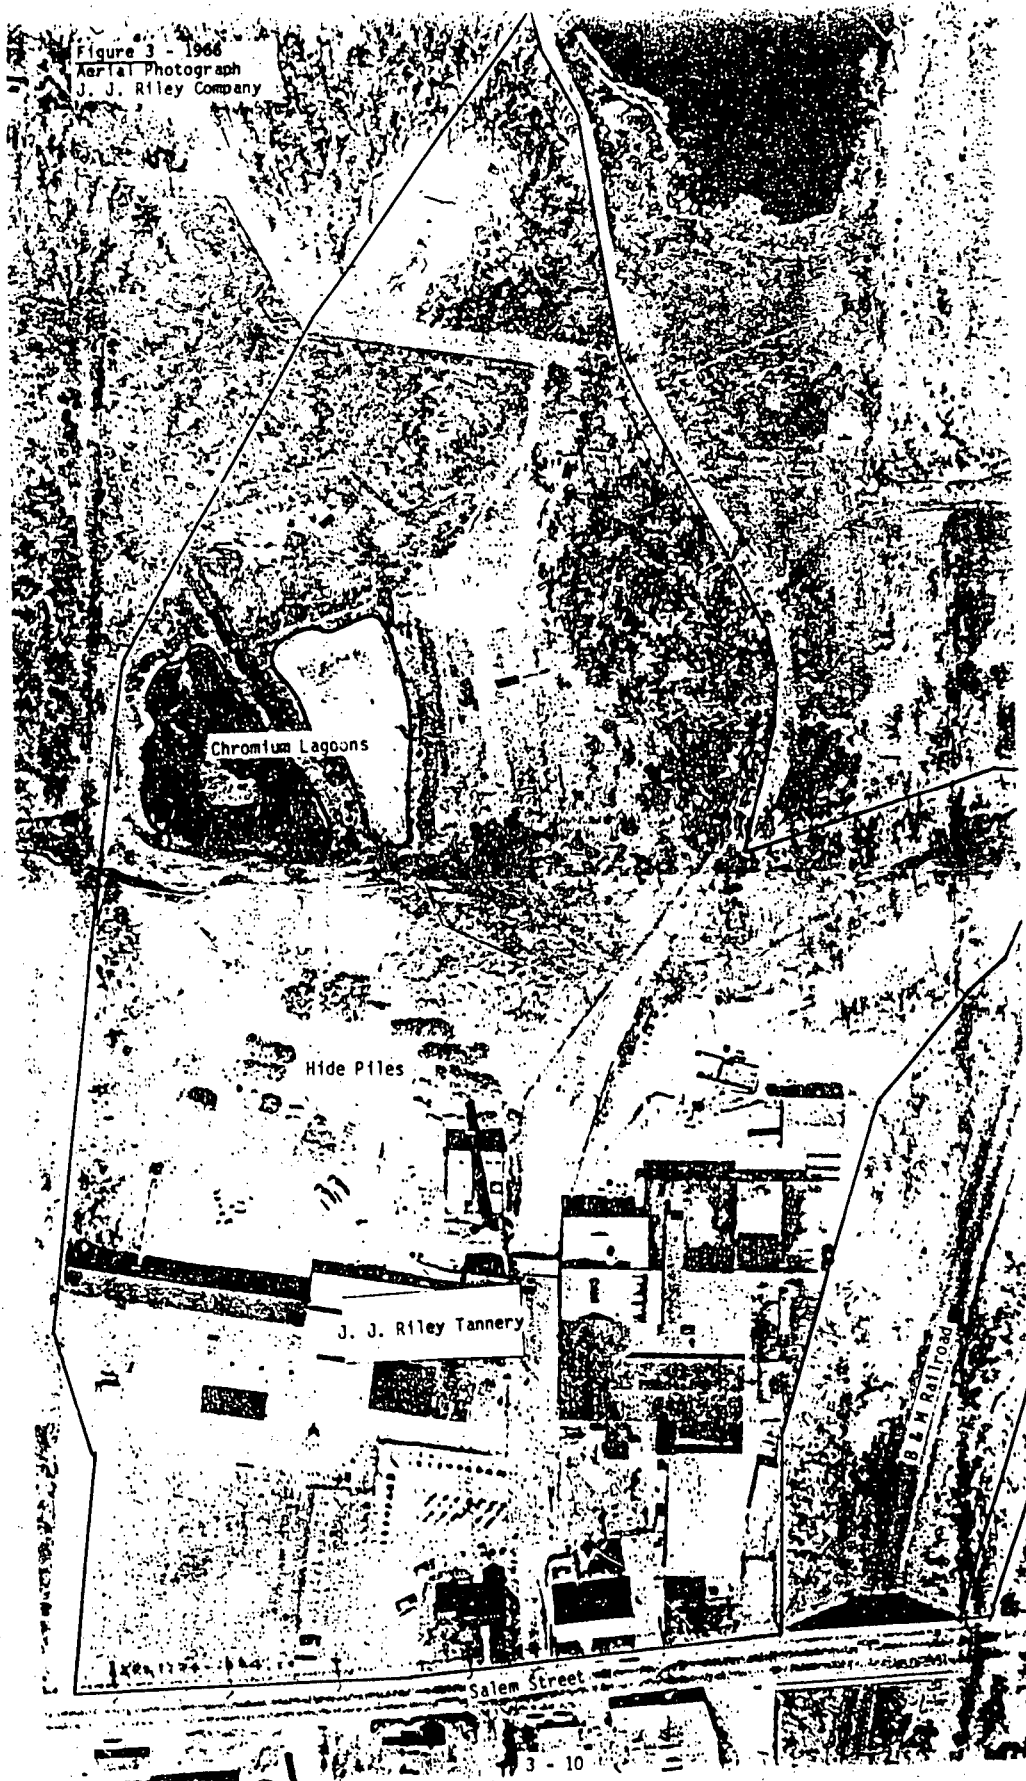
- 3.4.5 According to the May 13, 1980 DEQE investigation of the J. J. Riley Company, two chromium lagoons (See Figure 3) are located in a swampy area to the northwest of the paved area. At the time of the DEQE visit, the lagoons were partly covered with a "dirty, white, foamy substance of unknown origin". During this site investigation, one small four foot by seven foot area of standing water was present in the chromium lagoon area. The lagoon had a white crusted top, and the area surrounding it was densely vegetated. According to John Riley, chromium and benzidine dye wastes were dumped in the lagoons until ten years ago when use of the dyes was discontinued. The site inspection indicated no evidence of recent use of the lagoons. However, the lagoons pose a potential hazard from leaching of materials into the groundwater. Analysis of the well water samples should indicate if this has taken place.

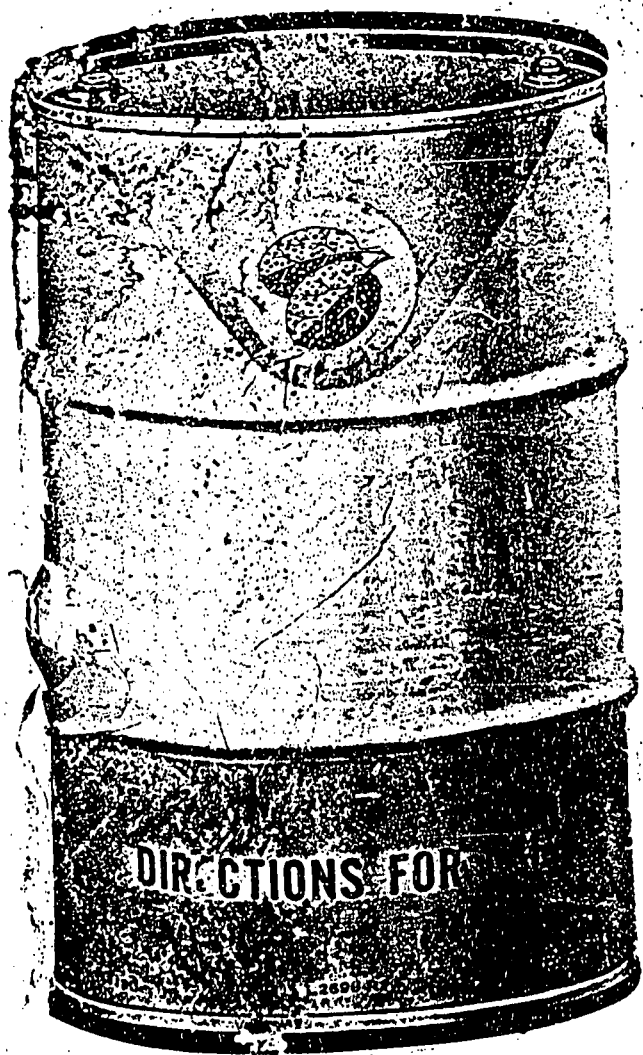
Figure D-1
Malathion LV
Concentrate Label
Found on J. J. Riley
Company Property

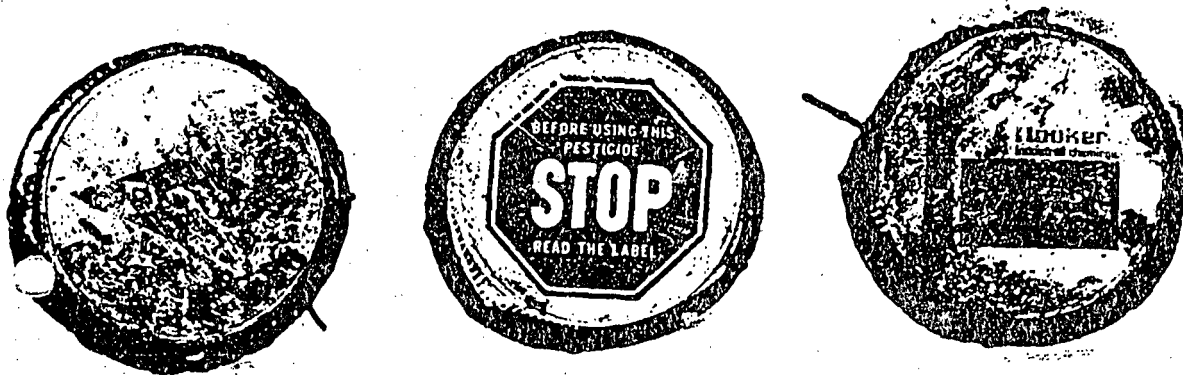
- 1135 - Work party discovers approximately one-hundred pesticide caps (See Appendix D) across the B & M tracks from Dickison Depot. Soil auger used; OVA reading 0 ppm.

Figure D-4
Pesticide Caps
found on J. J.
Riley Property
